Special Report 86-29

Cold Regions Research &
Engineering Laboratory

Blistering of built-up roof membranes *Pressure measurements*

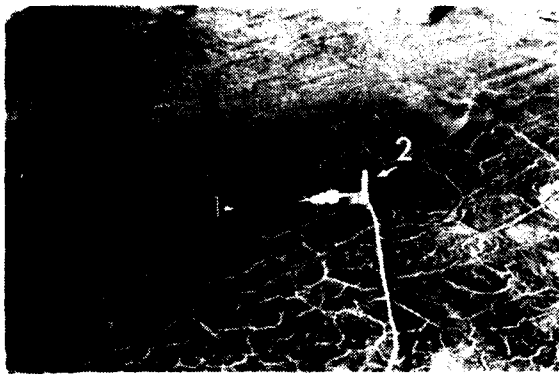
Figure 1. Blister that had been instrumented with a pressure sensor (2) and then opened to show the needle position (1).

Internal pressures were measured by inserting a hypodermic-type needle through the wall of a blister (Fig. 1). For this operation a side-vented needle (Fig. 2) worked best. Needles that were open only at the end became plugged with bitumen. The needle was sealed to the pressure sensing port of the Microswitch sensor. The sensor's other port was connected to a plastic tube vented in a bottle of desiccant at atmospheric pressure. This prevented moisture from entering the port and damaging the sensor.

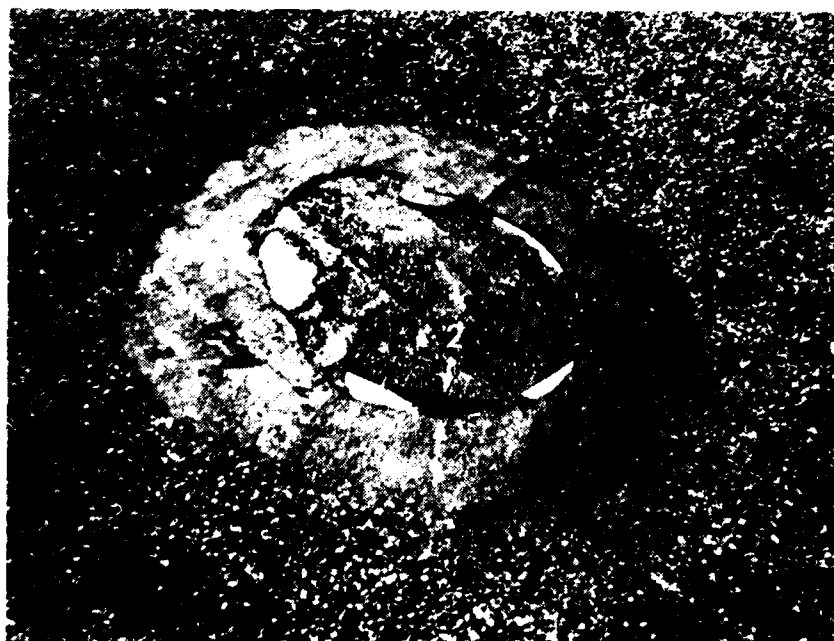
Figure 4. The Devens blister after it was cut. The assumed perimeter (1) did not always coincide with actual perimeter (2).

For the Devens blister, the area, length and weight were measured after the blister was removed from the roof and trimmed. Trimming was necessary because the cut edges did not coincide with the actual perimeter. As shown in Figure 4 the cut edge ran both inside and outside of the bond line. The membrane weight shown in Table 1 includes the weight of the surface gravel. The height was determined with the aid of a carpenter's

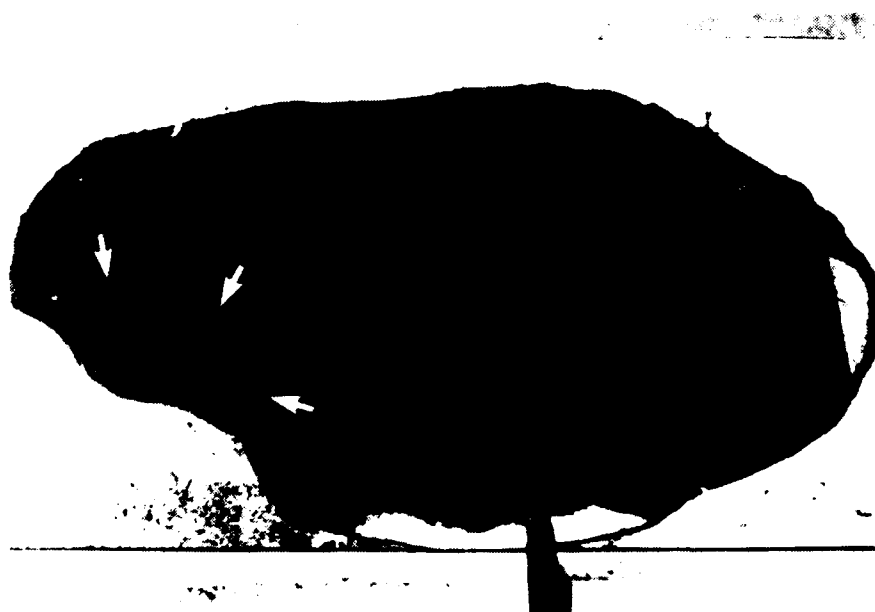
Figure 6. Evidence of foaming on the Devens blister. The long axis was oriented with the laying direction of the felts. The arrows point to an area of bubbled bitumen.

The blister in Figure 6 was elongated and its long axis was oriented with the laying direction of the felts. I found both circular and elongated blisters at Devens. The elongated ones were generally all oriented in the same direction. I cut into two circular blisters and saw no evidence of a felt lap joint like that in Figure 6. Perhaps felt laps provide a line of weakness along which blisters can expand.

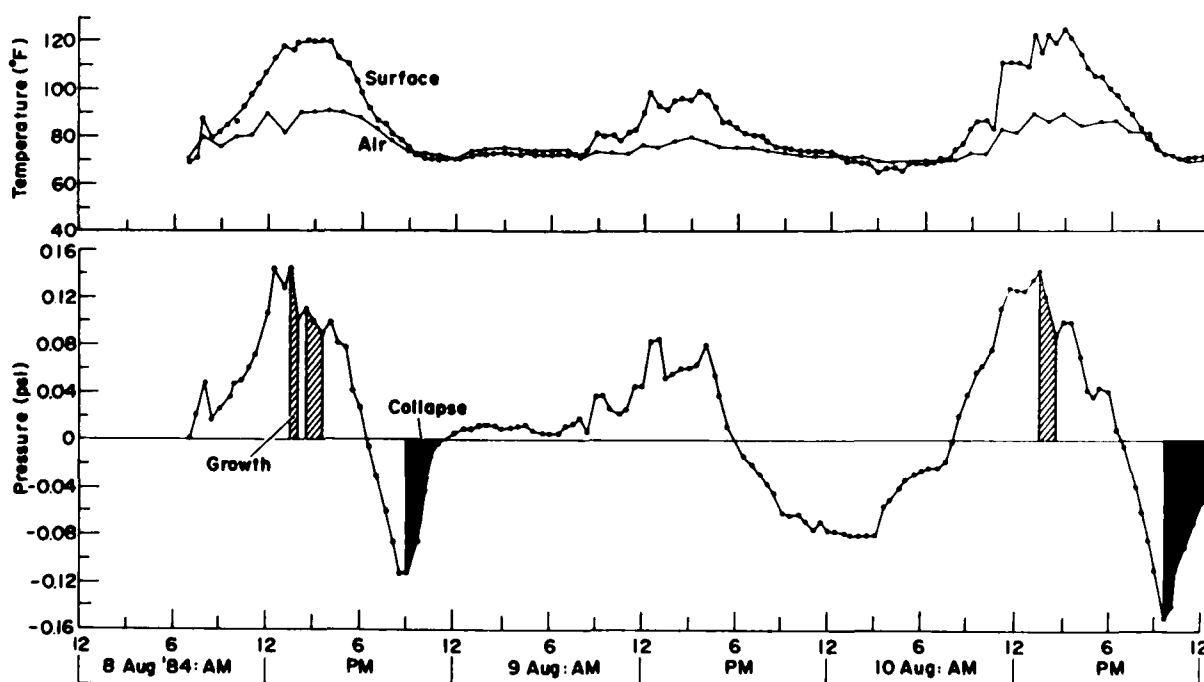
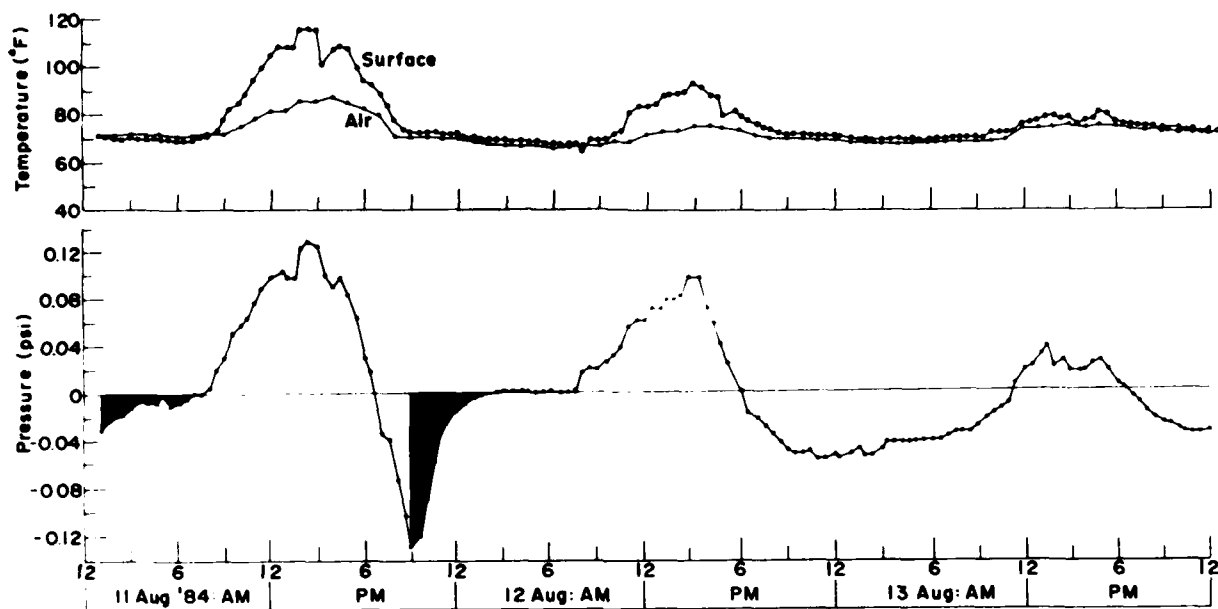
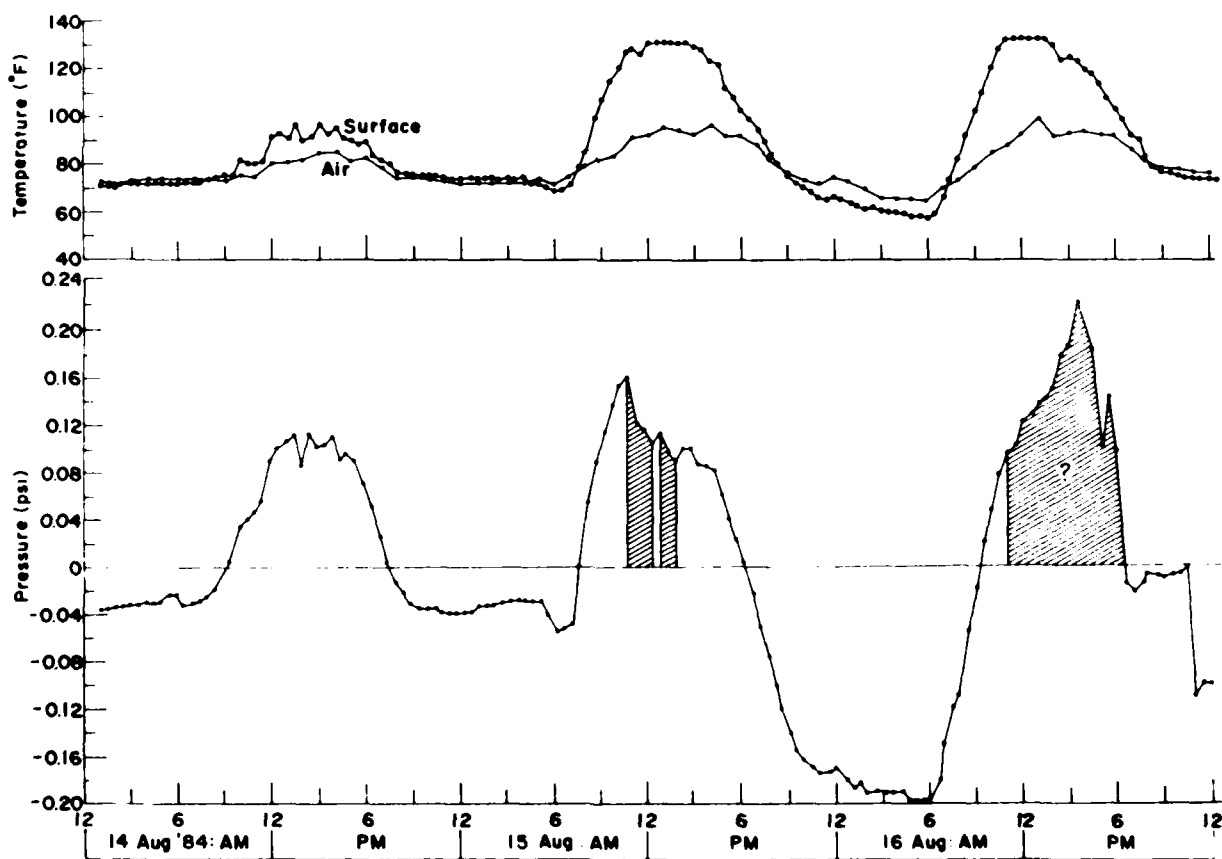
Figure 7. Temperatures and pressures for the Devens blister.

Figure 7 (cont'd). Temperature and pressures for the Devens blister.

Surface temperatures and internal pressures for each blister are shown in Figures 7-11. As can be seen, changes in roof surface temperature reflect changes in blister pressure. The pressures range from positive (above atmospheric pressure) during the heat of the day to negative (partial vacuum) during the cool of the night. If a blister were completely sealed and rigid, its internal pressures could be determined by referring to Figure 12, which was derived from the ideal gas law.

In over thirty days of field testing I found obvious indications of blister growth on only four days. On 8 August (Fig. 7), for example, the roof surface temperature at Fort Devens rose to a high of 120°F at 2 pm and held there for two hours. The pressure, meanwhile, rose to a high of 0.14 psi at 12:30 pm, dropped to 0.13 psi at 1 pm, and rose again to 0.14 psi at 1:30 pm. At 2 pm, when the surface temperature was still high, the pressure rapidly fell to 0.09 psi. This rapid drop in pressure, when it should have remained high, must be caused by an increase in the volume of the blister, as opposed to a sudden venting. In other words, the blister grew.

Nighttime temperatures significantly affect the daytime growth of a blister. During the evenings of 8, 10 and 11 August (Fig. 7) the roof surface temperatures remained at approximately 70°F from 11 pm until morning. The vacuum, instead of also remaining stable, began to rise rapidly shortly before midnight on each night. In these cases the blister walls were not rigid enough to resist the vacuum, so they partially collapsed, as indicated by the rapid pressure change. Collapses such as these inhibit growth the following day by reducing the amount of air that is drawn into a blister at night. For example, on the day following the 10 August collapse, no growth (that is, no sudden drop in pressure) was evident even though the temperatures were sufficiently high.

When nighttime collapses do not occur, on the other hand, the potential for growth is increased. On the evening of 15 August (Fig. 7), for example, the blister vacuum steadily increased as the temperature dropped. No sudden pressure change, indicating a collapse, was evident, so air must have been drawn into the blister all night. Consequently, daytime blister pressures were considerably higher on 16 August than on 15 August even though surface temperatures were essentially the same on each day. Of the four days of growth, the most growth appears to have occurred on 16 August (Fig. 7).

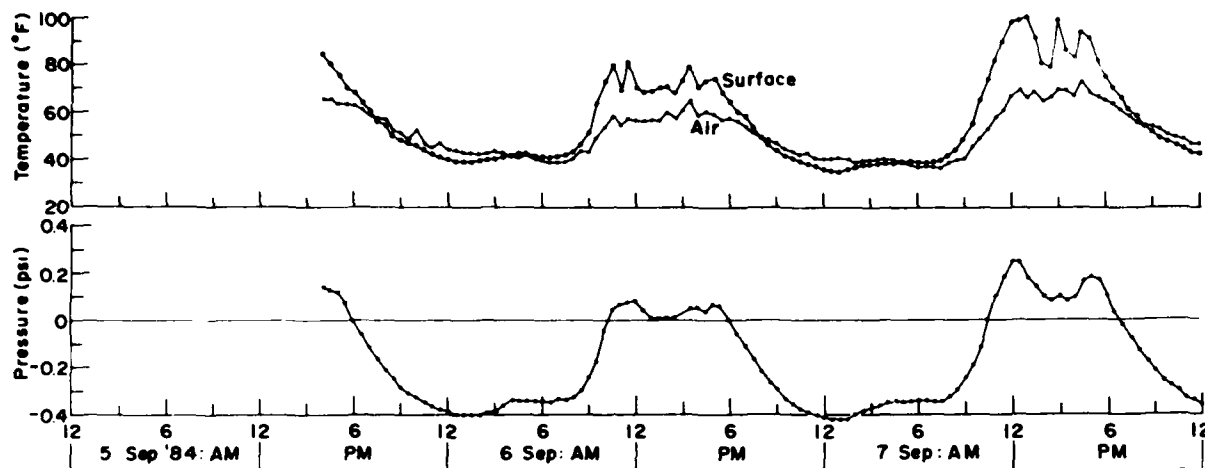
Figure 8. Temperatures and pressures for CRREL blister #1.

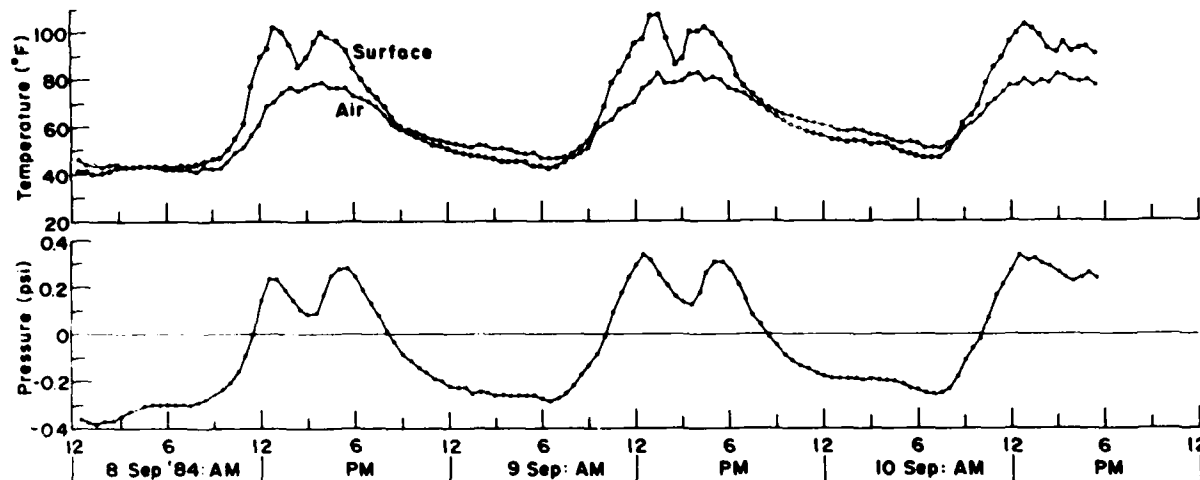
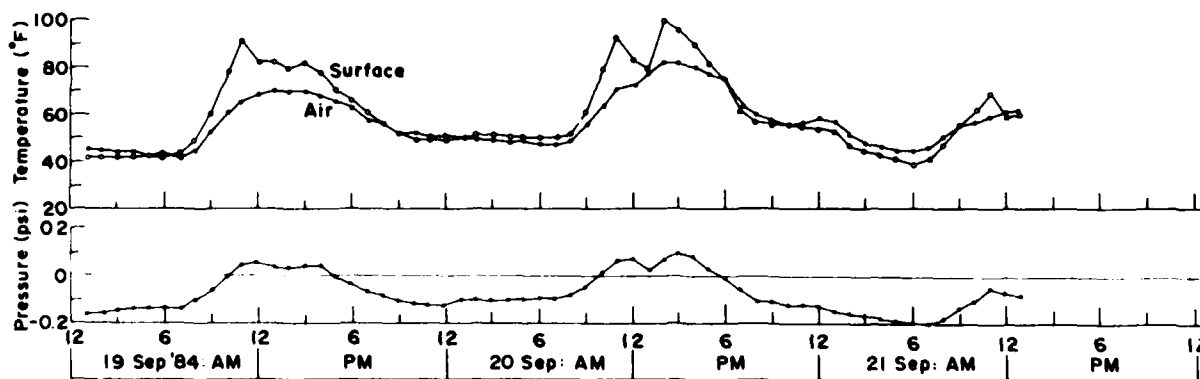
Figure 9. Temperatures and pressures for CRREL blister #2.

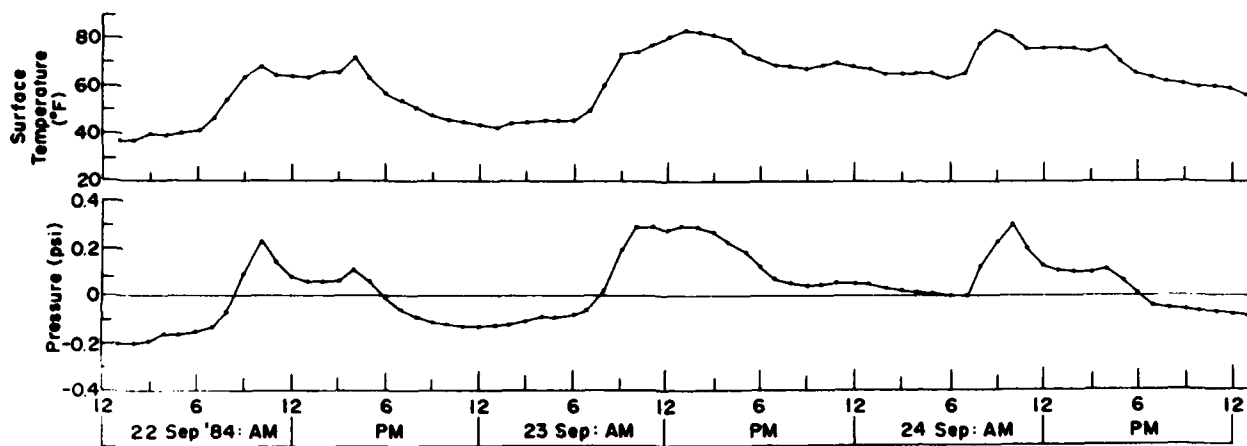
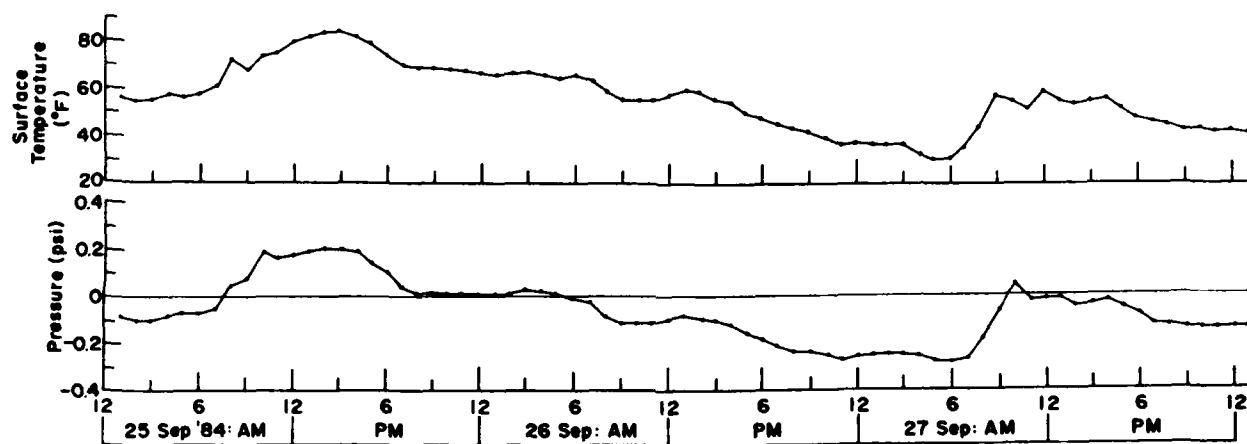
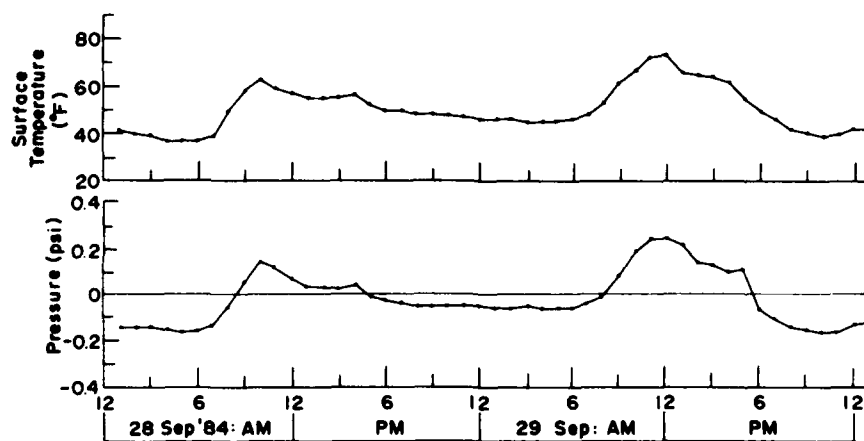
Figure 10. Temperatures and pressures for CRREL blister #3.

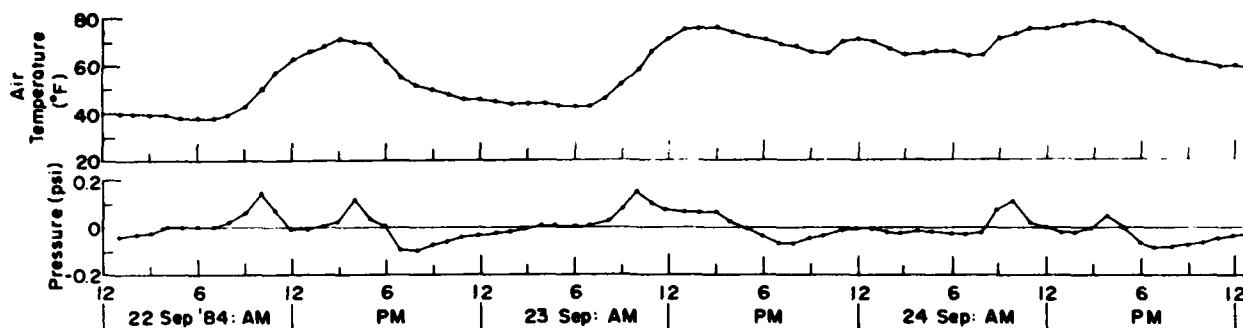
Figure 11. Temperatures and pressures for CRREL blister #4.

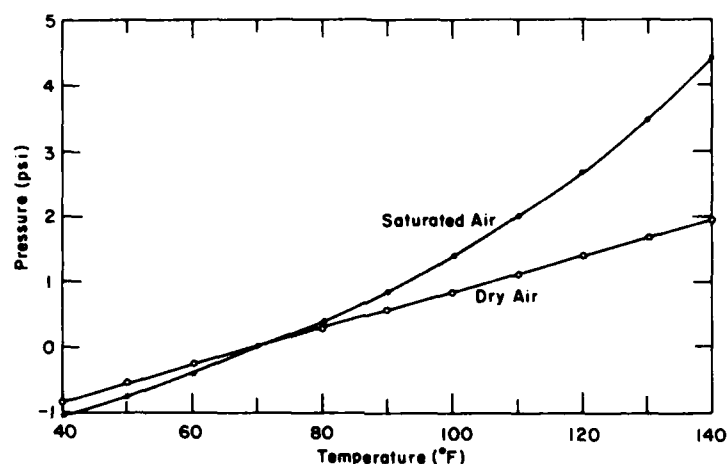
Figure 12. Pressure increases of dry and saturated air.

Comparison with Figures 7-11 shows that measured pressures are significantly less than Figure 12 would suggest. Figure 12 shows, for example, that dry air at 70°F and atmospheric pressure, when elevated to 100°F,

increases in pressure by 0.8 psi. If that air were saturated with moisture, the pressure increase would be 1.4 psi -- a considerable increase. In comparison, at 11:30 a.m. on 10 August (Fig. 7), the roof surface temperature at Devens was 112°F but the internal blister pressure was only 0.13 psi. Thus, theoretically, dry air alone is all that is required to create these pressures. This lower-than-expected pressure also indicates that air may be slowly escaping from the blister or that the blister may be expanding in volume or both.

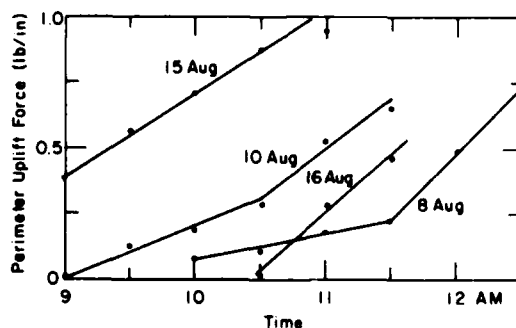
Figure 15. Perimeter uplift force vs time prior to growth.

Table 2 lists these forces along with the roof temperature for the four days when growth was evident. The rate of increase in uplift force along the perimeter of each blister just prior to growth (sudden pressure drop) is shown in Figure 15.

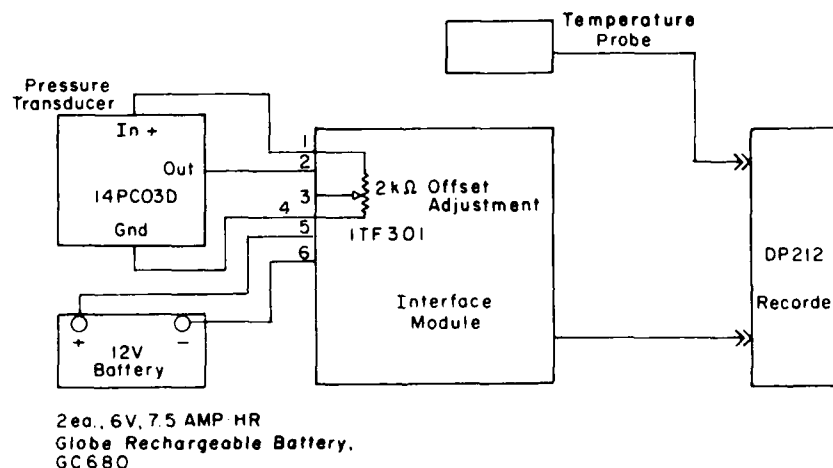
Figure A1. Data acquisition system.

An 8.0-V DC supply voltage was selected to produce a transducer output of exactly 1.0 V per psi, with a 3.5-V offset at ambient atmospheric pressure (Fig. A1). A 2-K Ω , 22-turn resistance potentiometer,* connected across the transducer's voltage supply, was adjusted to produce a transducer offset of 0.50 V at atmospheric pressure. This allowed pressures to be read in the range of -0.50 psi to 1.5 with a 0-2.0 V output.
